Manhole Inspection Summary

Manhole # S39GG_001MH

Insp Date: **3/28/07 12:52 PM**

Location Address: **1316 VALLEY ST**

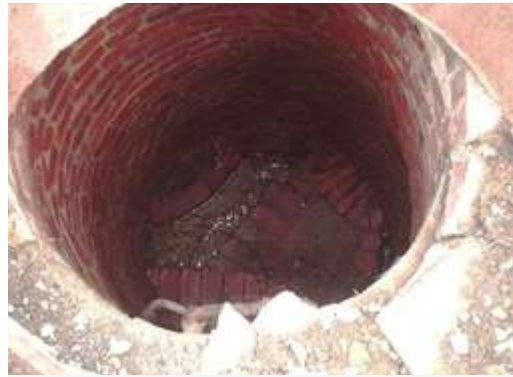
Top View

Barrel infiltration. Bench and Channel debris.

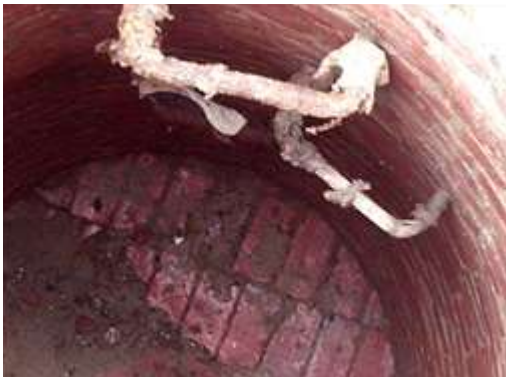
Defect

Barrel infiltration. Corroded steps. Evidence of surcharge.

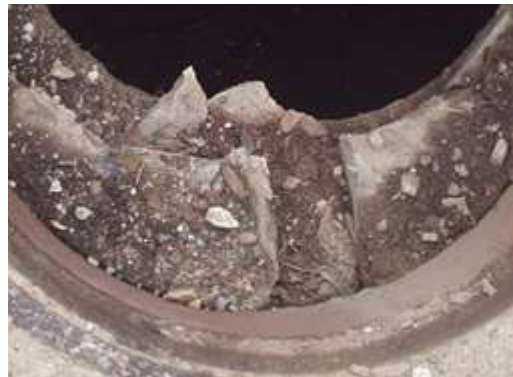
Defect

Frame leaks. Frame offset. Adjustment deterioration and infiltration.

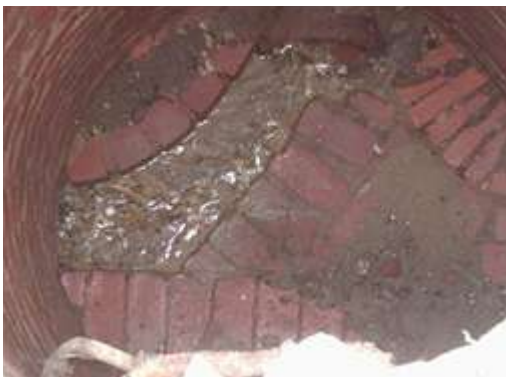
Defect

Bench and Channel debris.

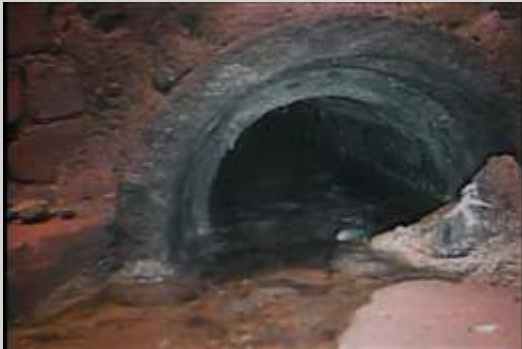
8 in. Circular Gravity Sewer Pipe Out @ 12 O'Clock

Deposits: ☐ None ☒ **Mud** ☐ Sludge ☒ **Debris** ☐ Grease

Silt Depth: **1** (in.) Deposits Extent: **Light**

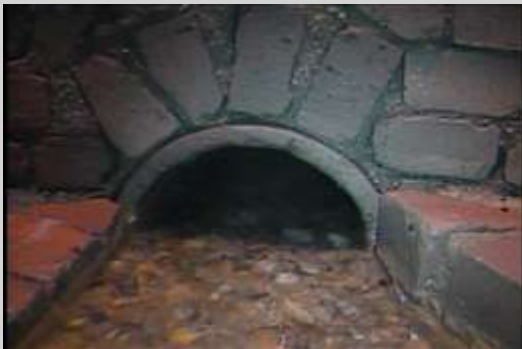
8 in. Circular Gravity Sewer Pipe In @ 9 O'Clock

Deposits: ☐ None ☒ **Mud** ☐ Sludge ☒ **Debris** ☐ Grease

Silt Depth: **4** (in.) Deposits Extent: **Heavy**
